**DEPARTMENT OF TRANSPORTATION**

Contract #: 04-0120F4Cty: SF/ALA Rte: 80 PM: 13.2/13.9File #: 69.28**WELDING INSPECTION REPORT****Resident Engineer:** Pursell, Gary**Address:** 333 Burma Road**City:** Oakland, CA 94607**Report No:** WIR-012042**Date Inspected:** 15-Jan-2010**Project Name:** SAS Superstructure**OSM Arrival Time:** 700**Prime Contractor:** American Bridge/Fluor Enterprises, a JV**OSM Departure Time:** 1900**Contractor:** Zhenhua Port Machinery Company, Ltd (ZPMC), Changxing Island **Location:** Shanghai, China

**TOWER ASSEMBLY AREA**

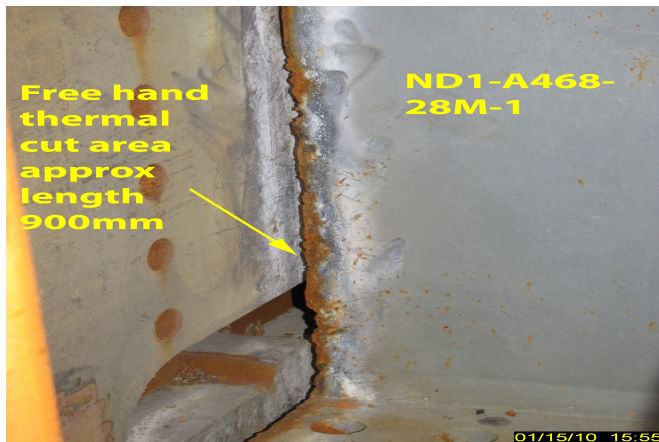
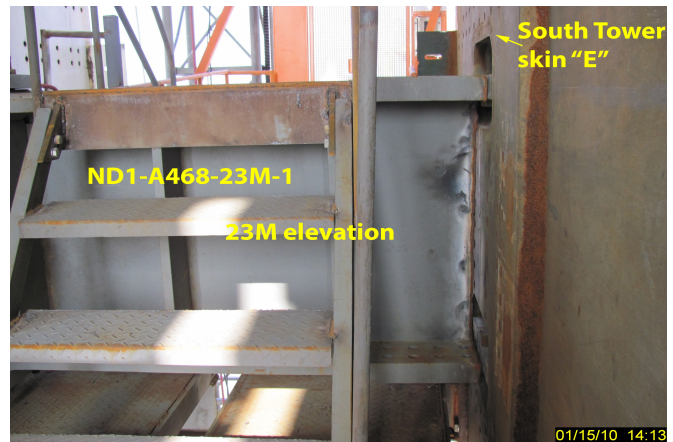
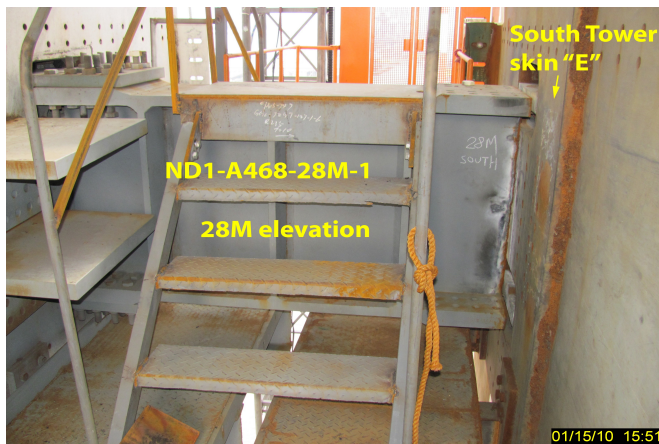
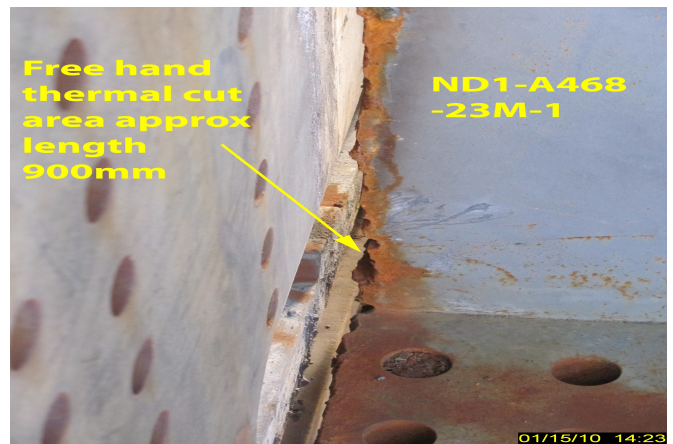
During the random Quality Assurance(QA) in process verification of Tower strut, this QA Inspector observed free hand thermal cutting were carried out on edges of the strut plates towards South Tower side. The struts are identified as ND1-A468-23M-1 at elevation level 23M and ND1-A468-28M-1 at elevation level 28M. The thermal cut area is measured approximately 900mm for each strut. The material is designated as Seismic Performance Critical Member (SPCM). The member is located at Tower assembly area (Jetty Area). This issue has an incident report.

The attached photographs provide additional detail.
